## **Green Water on Norwegian Production Ships**

*Gerhard Ersdal and Arne Kvitrud  
Norwegian Petroleum Directorate  
Stavanger, Norway*

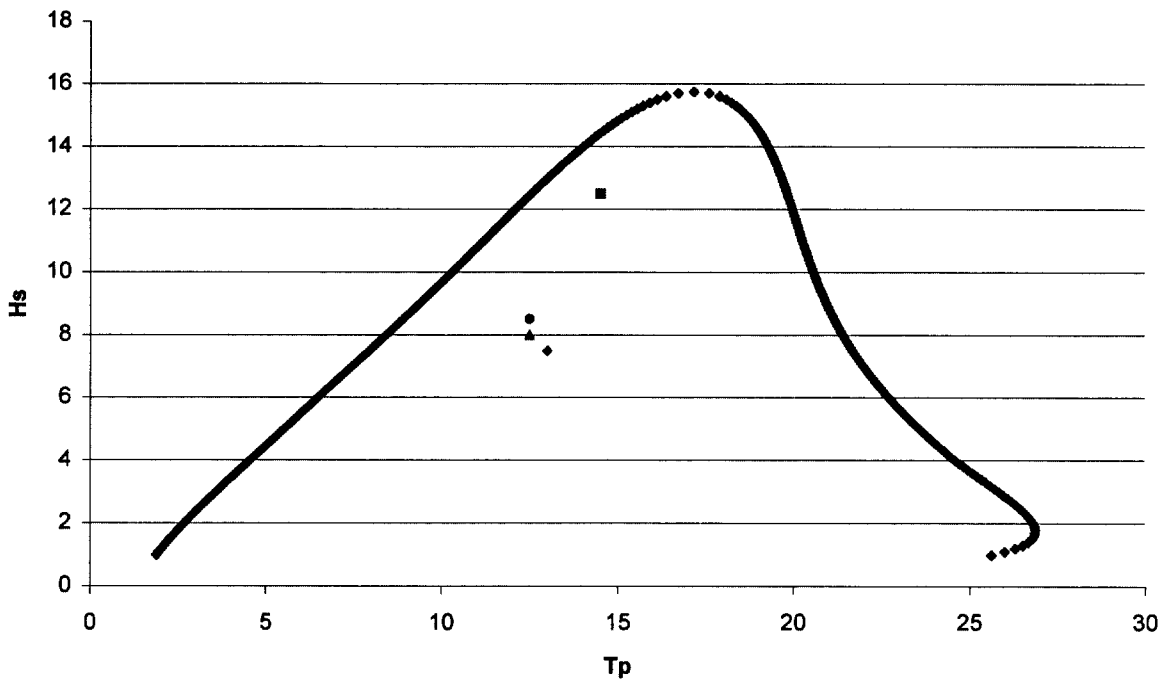
**Figure 3,** The green water events on Norwegian production ships and a  $H_s - T_p$  design curves with the annual probability of exceedance of  $10^{-2}$  for the Haltenbanken area. The incidents occurred at sea states significantly lower than the design sea states

The green water incidents recorded are plotted in figure 3 together with a 100-year contour line for the Haltenbanken area. The figure shows very clearly that the green water has occurred at significant wave heights much smaller than the 100-year values. The figure also indicates that the incidents have all occurred at peak periods lower than the peak period of the maximum significant wave height in the  $H_s-T_p$  design curves. The peak period where green water has occurred is closer to the pitch forcing period (the wave period when the wave length is equal to the ship's length assuming deep water).
