Green Water on Norwegian Production Ships

*Gerhard Ersdal and Arne Kvitrud
Norwegian Petroleum Directorate
Stavanger, Norway*

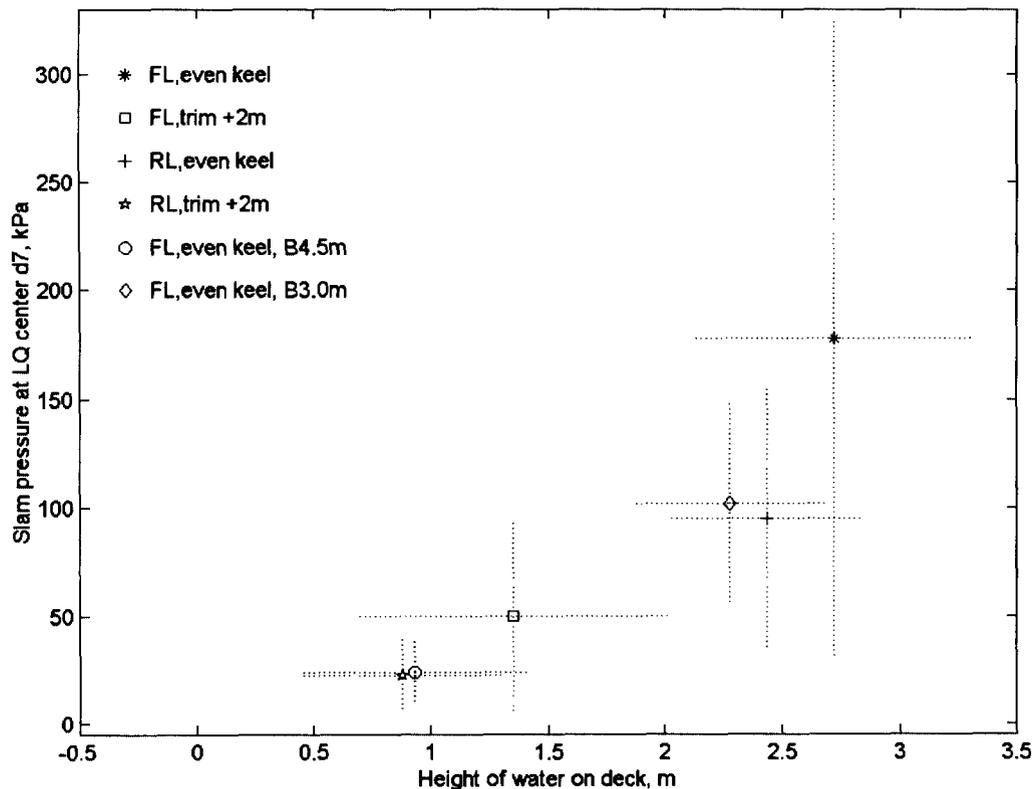
A new model test was performed in a 1:55 scale in 1999 at Marintek (Nygaard, 1999). The test consisted of a limited number of wave groups, selected from a regular simulation as a wave groups leading to large amounts of green water or large slam on living quarter. These wave groups was repeated 20-40 times. The results of these repeated wave groups gave a large scatter in results. A maximum water velocity of 14 m/s in a height of 4 m was found at midship (Børve, 1999). Different modifications was tested and compared to the as is situation. Figure 2 show a summary of the results from these tests (Børve, 1999). Although there is a large scatter in the results from each configuration, the mean values indicates a clear trend in positive effect of modifications as both slam pressure and height of green water decreases with the different modifications.

Figure 2, Pressure on living quarter versus height of water on deck for various configurations of modifications to the Varg ship. FL: fully loaded, RL: reduced loading (1.5m decrease in draft), B: increased bow. Mean values are marked, variations are indicated (Børve 1999).

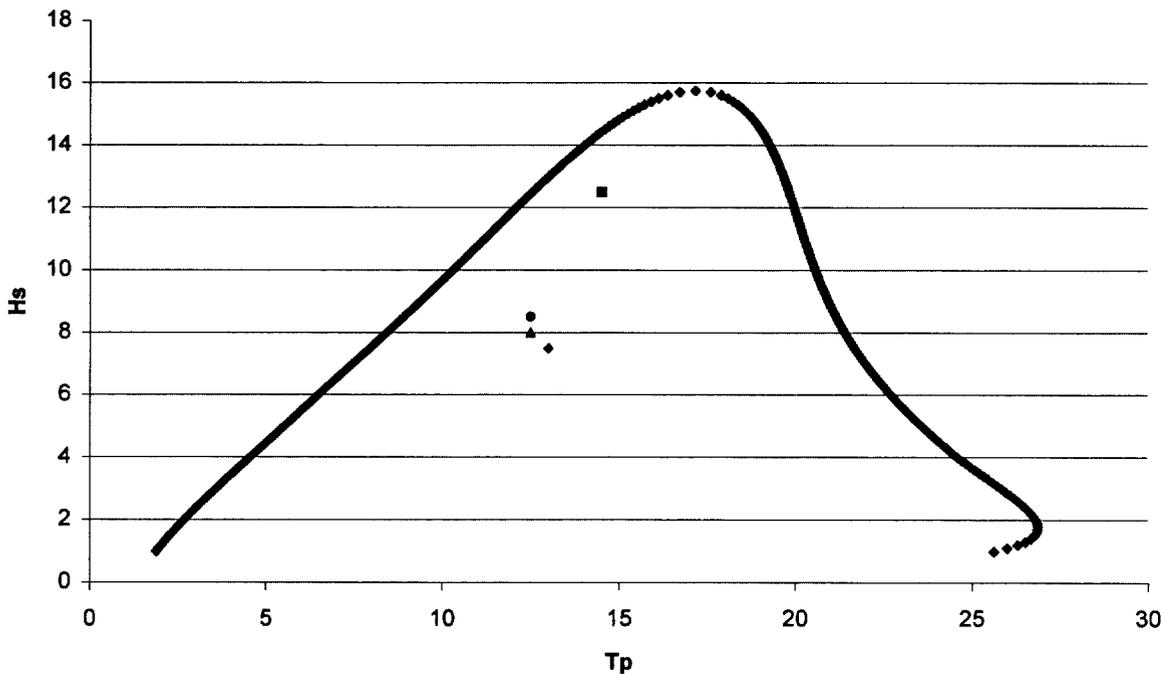
Figure 3, The green water events on Norwegian production ships and a $H_s - T_p$ design curves with the annual probability of exceedance of 10^{-2} for the Haltenbanken area. The incidents occurred at sea states significantly lower than the design sea states

The green water incidents recorded are plotted in figure 3 together with a 100-year contour line for the Haltenbanken area. The figure shows very clearly that the green water has occurred at significant wave heights much smaller than the 100-year values. The figure also indicates that the incidents have all occurred at peak periods lower than the peak period of the maximum significant wave height in the H_s-T_p design curves. The peak period where green water has occurred is closer to the pitch forcing period (the wave period when the wave length is equal to the ship's length assuming deep water).
