# Green water incidents on Norwegian production ships

By Gerhard Ersdal and Arne Kvitrud  
Norwegian Petroleum Directorate  
Stavanger, Norway

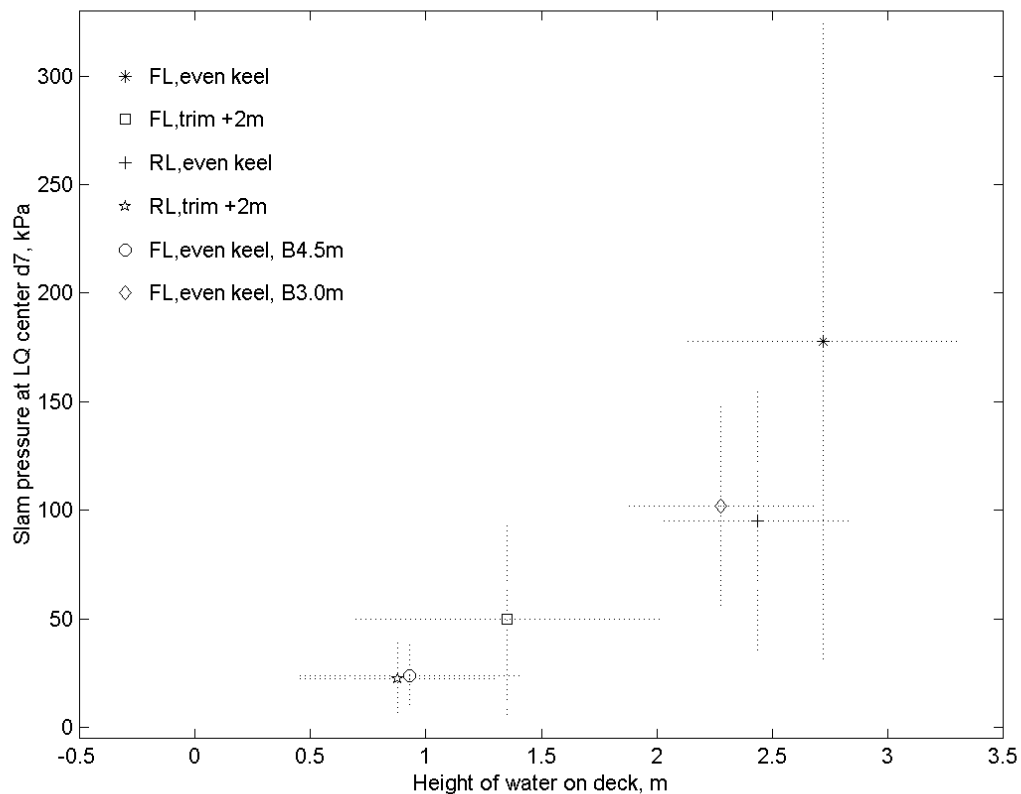
**Figure 2**, Pressure on living quarter versus height of water on deck for various configurations of modifications to the Varg ship. FL: fully loaded, RL: reduced loading (1.5m decrease in draft), B: increased bow. Mean values are marked, variations are indicated (Børve 1999).

A new model test was performed in a 1:55 scale in 1999 at Marintek (Nygaard, 1999). The test consisted of a limited number of wave groups, selected from a regular simulation as a wave groups leading to large amounts of green water or large slam on living quarter. These wave groups were repeated 20-40 times. The results of these repeated wave groups gave a large scatter in results. A maximum water velocity of 14 m/s in a height of 4 m was found at midship (Børve, 1999). Different modifications was tested and compared to the as is situation. Figure 2 shows a summary of the results from these tests (Børve, 1999). Although there is a large scatter in the results from each configuration, the mean values indicates a clear trend in positive effect of modifications as both slam pressure and height of green water decreases with the different modifications.

During the spring of 1999, local protection was fitted for critical equipment, windows and helideck support. In addition some operational measures have been taken related to draft, trim and personnel access to green water zones for the future (Børve, 1999).

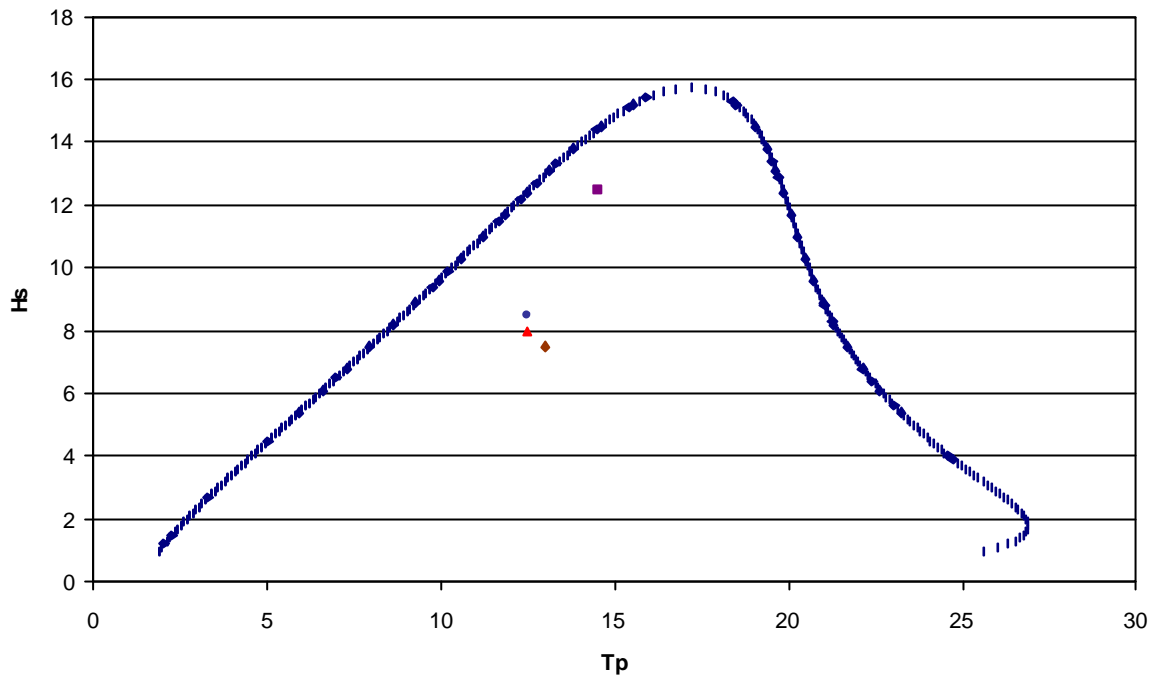
**Figure 3**, Sea states with green water events on Norwegian production ships presented in a  $H_s - T_p$  diagram together with design curves with the annual probability of exceedance of  $10^{-2}$  for the Haltenbanken area.

The green water incidents recorded are plotted in figure 3 together with a 100-year contour line for the Haltenbanken area. The figure shows very clearly that the green water has occurred at significant wave heights much smaller than the 100-year values. The figure also indicates that the incidents have all occurred at peak periods lower than the peak period of the maximum significant wave height in the  $H_s-T_p$  design curves. The peak period where green water has occurred is closer to the pitch forcing period (the wave period when the wave length is equal to the ship's length assuming deep water).
