## **Green Water on Norwegian Production Ships**

*Gerhard Ersdal and Arne Kvitrud  
Norwegian Petroleum Directorate  
Stavanger, Norway*

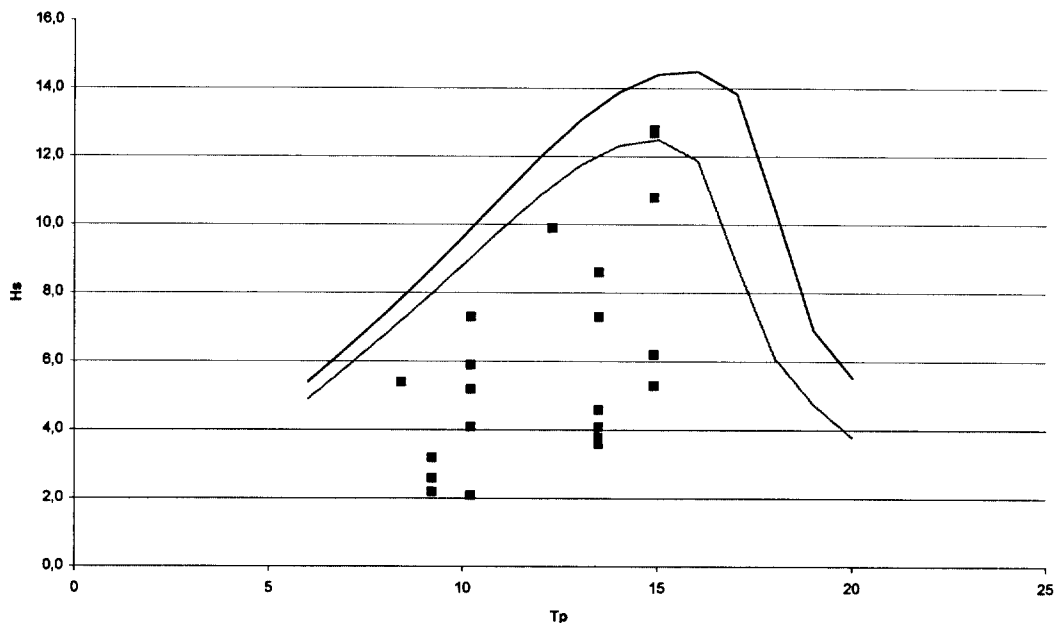
**Figure 1**, The  $H_s - T_p$  design curves with the annual probability of exceedance of  $10^{-1}$  and  $10^{-2}$  for the Varg field. The hindcast data from nearby locations (Latitude 57.99N, longitude 1.78E) for January 29<sup>th</sup> 2000 is also included. The data is produced using WINCH hindcast model at DNMI. The data is not calibrated.

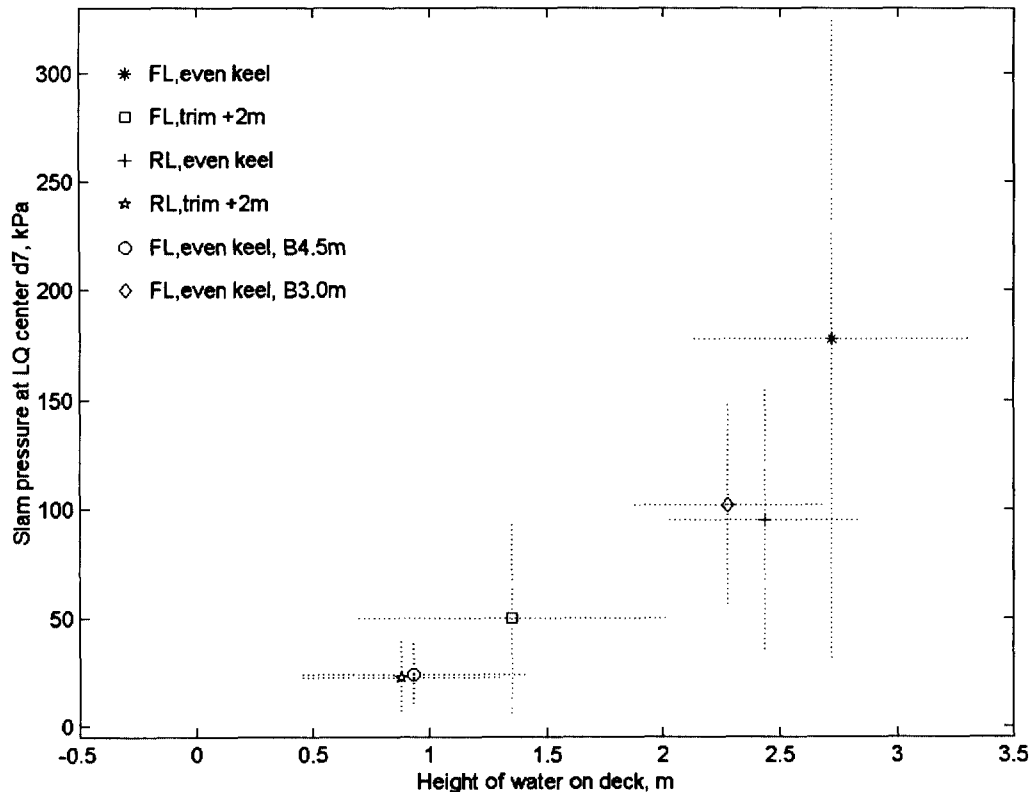
A new model test was performed in a 1:55 scale in 1999 at Marintek (Nygaard, 1999). The test consisted of a limited number of wave groups, selected from a regular simulation as a wave groups leading to large amounts of green water or large slam on living quarter. These wave groups was repeated 20-40 times. The results of these repeated wave groups gave a large scatter in results. A maximum water velocity of 14 m/s in a height of 4 m was found at midship (Børve, 1999). Different modifications was tested and compared to the as is situation. Figure 2 show a summary of the results from these tests (Børve, 1999). Although there is a large scatter in the results from each configuration, the mean values indicates a clear trend in positive effect of modifications as both slam pressure and height of green water decreases with the different modifications.

**Figure 2,** Pressure on living quarter versus height of water on deck for various configurations of modifications to the Varg ship. FL: fully loaded, RL: reduced loading (1.5m decrease in draft), B: increased bow. Mean values are marked, variations are indicated (Børve 1999).
