Green Water on Norwegian Production Ships

*Gerhard Ersdal and Arne Kvitrud
Norwegian Petroleum Directorate
Stavanger, Norway*

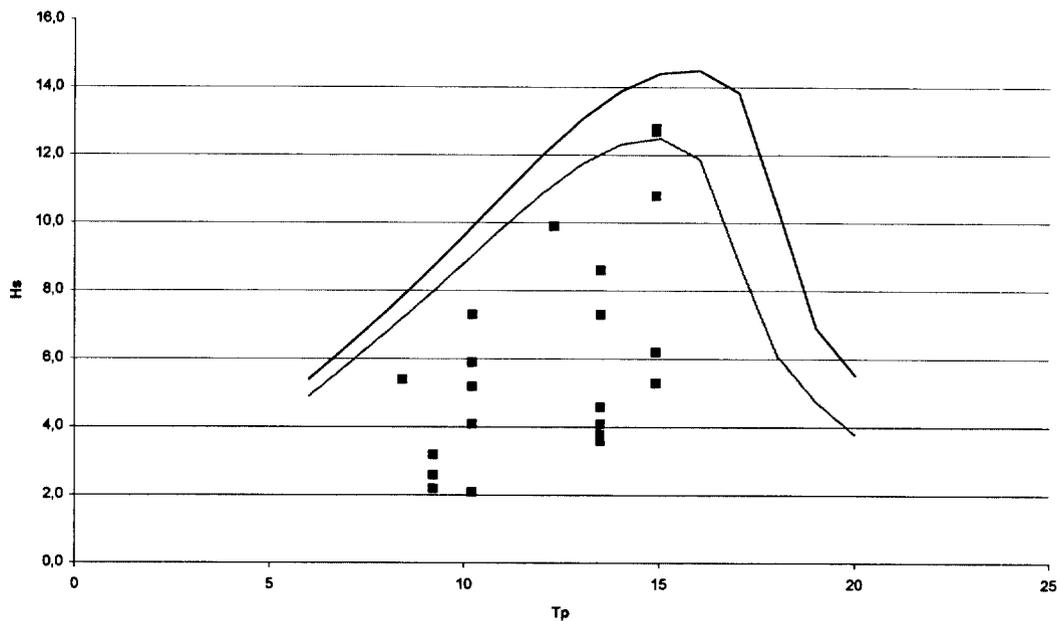
The most critical event so far on the Norwegian sector, occurred at the Varg field the January 29th 2000. Hydro (Ljosland, 2000) reported damages to the Petrojarl Varg ship during a storm on fore ship, midship and aft ship. The significant wave height is estimated to about 12.5 m, and the peak period is estimated to 14.5 s at the time of the incident (personal information from Knut Iden). The available hindcast data for WINCH point (Latitude 57.99N, longitude 1.78E) close to the Varg field is shown in figure 1 together with the H_s - T_p design curves with the annual probability of exceedance of 10^{-1} and 10^{-2} for the Varg field. The estimated seastate is close to a 10 year situation. The incident occurred when the ship was close to fully loaded with a static trim of a little less than 1 degree.

Figure 1, The $H_s - T_p$ design curves with the annual probability of exceedance of 10^{-1} and 10^{-2} for the Varg field. The hindcast data from nearby locations (Latitude 57.99N, longitude 1.78E) for January 29th 2000 is also included. The data is produced using WINCH hindcast model at DNMI. The data is not calibrated.
