# Green water incidents on Norwegian production ships

By Gerhard Ersdal and Arne Kvitrud  
Norwegian Petroleum Directorate  
Stavanger, Norway

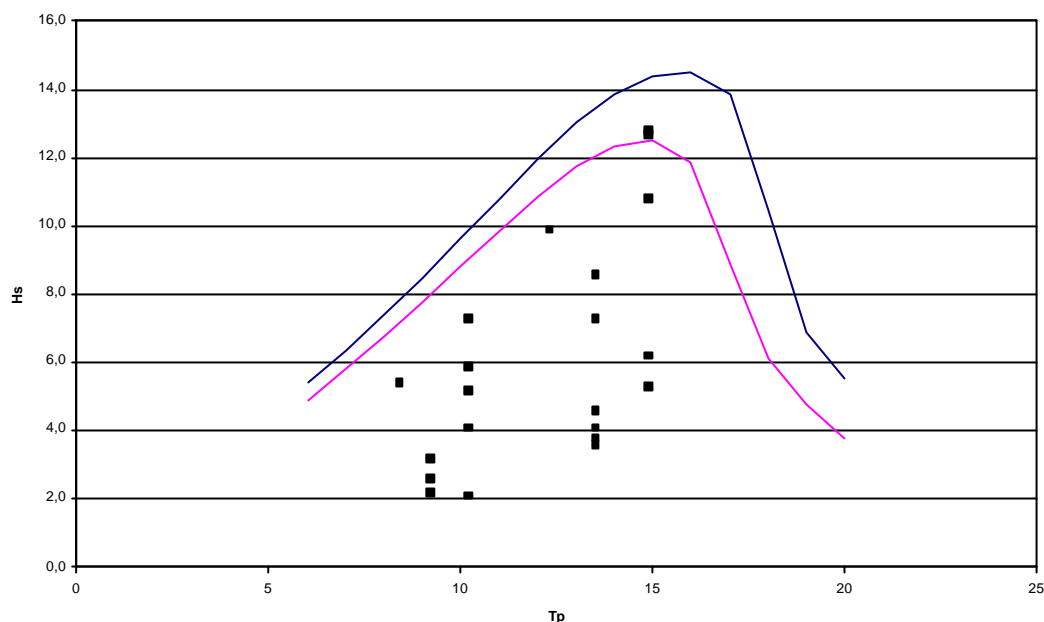
**Figure 1**, The  $H_s - T_p$  design curves with the annual probability of exceedance of  $10^{-1}$  and  $10^{-2}$  for the Varg field. The hindcast data from nearby locations (Latitude 57.99N, longitude 1.78E) for January 29<sup>th</sup> 2000 is also included. The data is produced using WINCH hindcast model at DNMI. The data is not calibrated.
